DAMAGE MECHANICS OF MEMBERS IN STEEL RAILWAY BRIDGES

1- ABSTRACT

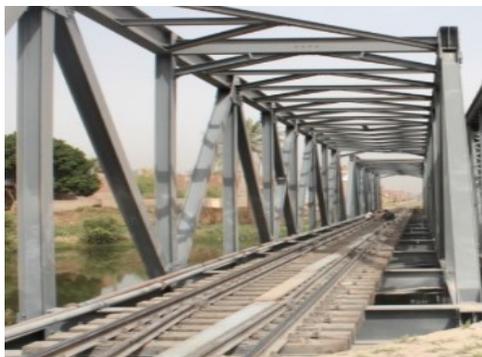
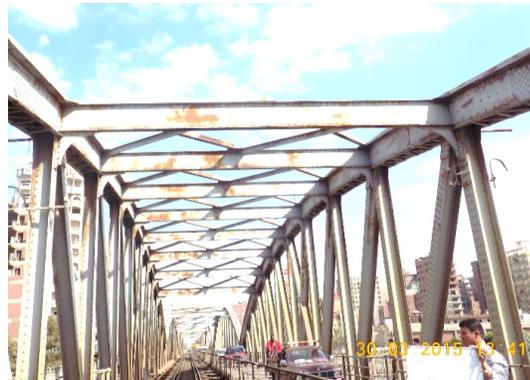
Fig. 4. 3-D finite element model of (a) Gerga & (b) Zifta Bridge

The bridges dimensions are then sized in 3-D modeling for the bridges **Fig. 4** which represent advanced technique toward the original available 2-D analysis. In addition to the study of the recent bridge cases due to the changes in train speed, and the number of passing cars of locomotives, passengers and goods are obtained from recoded data.

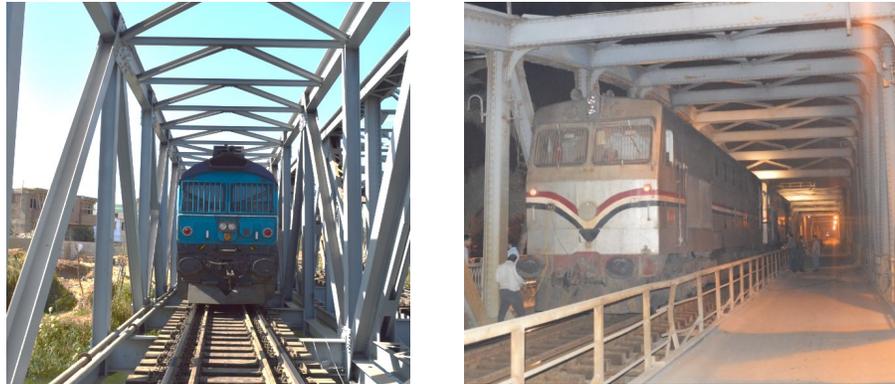
Fig. 5. Gerga & Zifta Loading Test (Locomotive Wagon)

The model is further updated in accordance with tests carried out on site for materials and loading tests Fig. 5 seeking for the real stresses in

members. The non-destructive tests include ultrasonic tests, hardness, welding and paint thicknesses

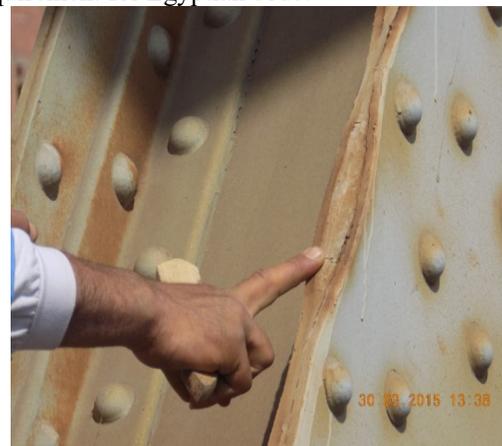
Fig. 7. Zefta railway bridge' Tension Buckling effect

One of the main causes of the sections reduction in their thicknesses is when the metal starts to corrode and rusts packs overtime in between the plane of the flanges' assembled surface. Reaching a significant pack rust, the plates shall be overstressed and it may buckle

locally between rivets connecting the sections of the bridge member.

The damage mechanics problem in Zefta bridge due to tension buckling or wrinkling in the thin plate due to pack rust were observed at the tension diagonal member of truss main girder section Fig. 7. The tension members were firstly rusted, became thinner at their edges with increasing the width to depth ratio, thus resulting in local buckling appeared between wider spaced rivets. However, the structure analysis showed that the tension diagonal member section satisfies the stress requirement for Egyptian code.

The repair solution for the tension diagonal members of truss of Zefta bridge is proposed by rust cleaning and refilling of swelled parts and

introducing additional bolts at the space between old bolts for the positions of buckled parts, as in **Fig. 9**
