LEATHER INDUSTRY FROM MAGRA EL OYOUN TO ROBBEKY

Dr. Hussein H. Abbas*

Synopsis

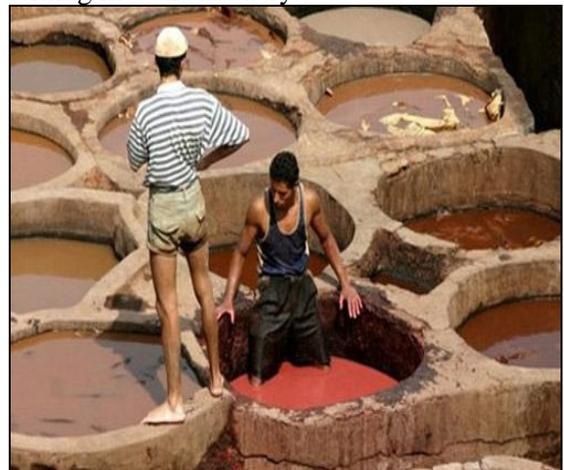
Figure 5 - Polluting Tanning Industry

Tannery processing impacts negatively the environment and the health risks among the workers employed in the leather tanneries. Various chemicals are used during the soaking, tanning and post tanning processing of animal skins. The chemical used consists of sodium hydrosulphide and chromium sulphate both are known to be carcinogenic agents. Fig.(5) shows cheap labors working in a dirt industry.
